**PERENNIAL FLOW DETERMINATION
POTOMAC TECHNOLOGY PARK
(161 DATA CENTER)
PRINCE WILLIAM COUNTY, VIRGINIA**

TNT PROJECT NO.: 1980

PWC PLAN NUMBER: ASP2022-00014S01

Reference: Perennial Flow Determination, Potomac Technology Park (161 Data Center),
Prince William County, Virginia
PWC Plan Number: ASP2022-00014S01
Latitude: 38°37'41" N, Longitude: -77°25'15" W

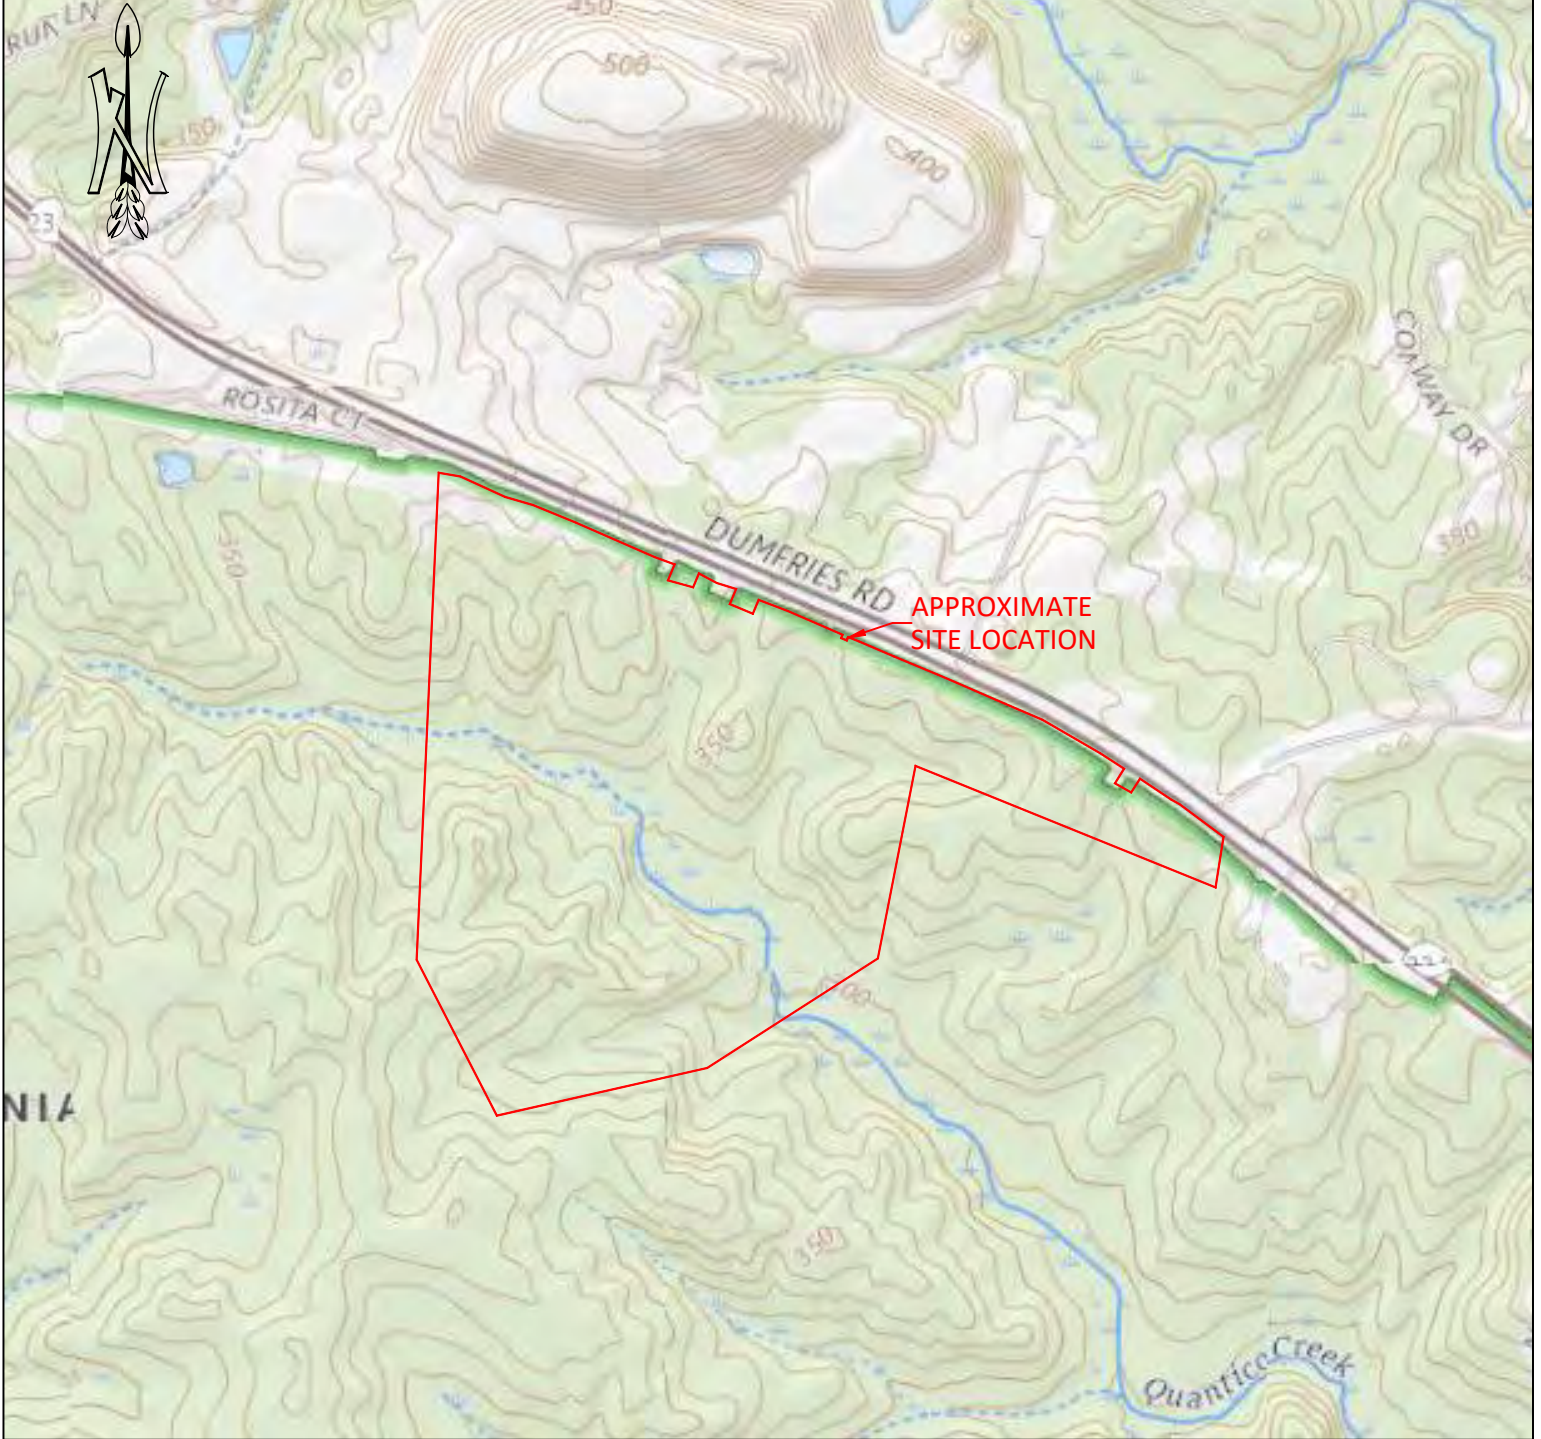
FIGURE 2

The USGS Independent Hill and Joplin quadrangle map show elevations of approximately 390 feet above mean sea level (MSL) in the Northwest portion of the site and approximately 305 feet above MSL in the central portions. As shown on the USGS Map, the project site drains to Quantico Creek, located within the Chesapeake Bay watershed and identified as Hydrologic Unit Code (HUC) 02070010. The NWI map depicts freshwater emergent, freshwater forested/shrub, and riverine wetland features within the project site boundaries.

TOPOGRAPHIC MAP

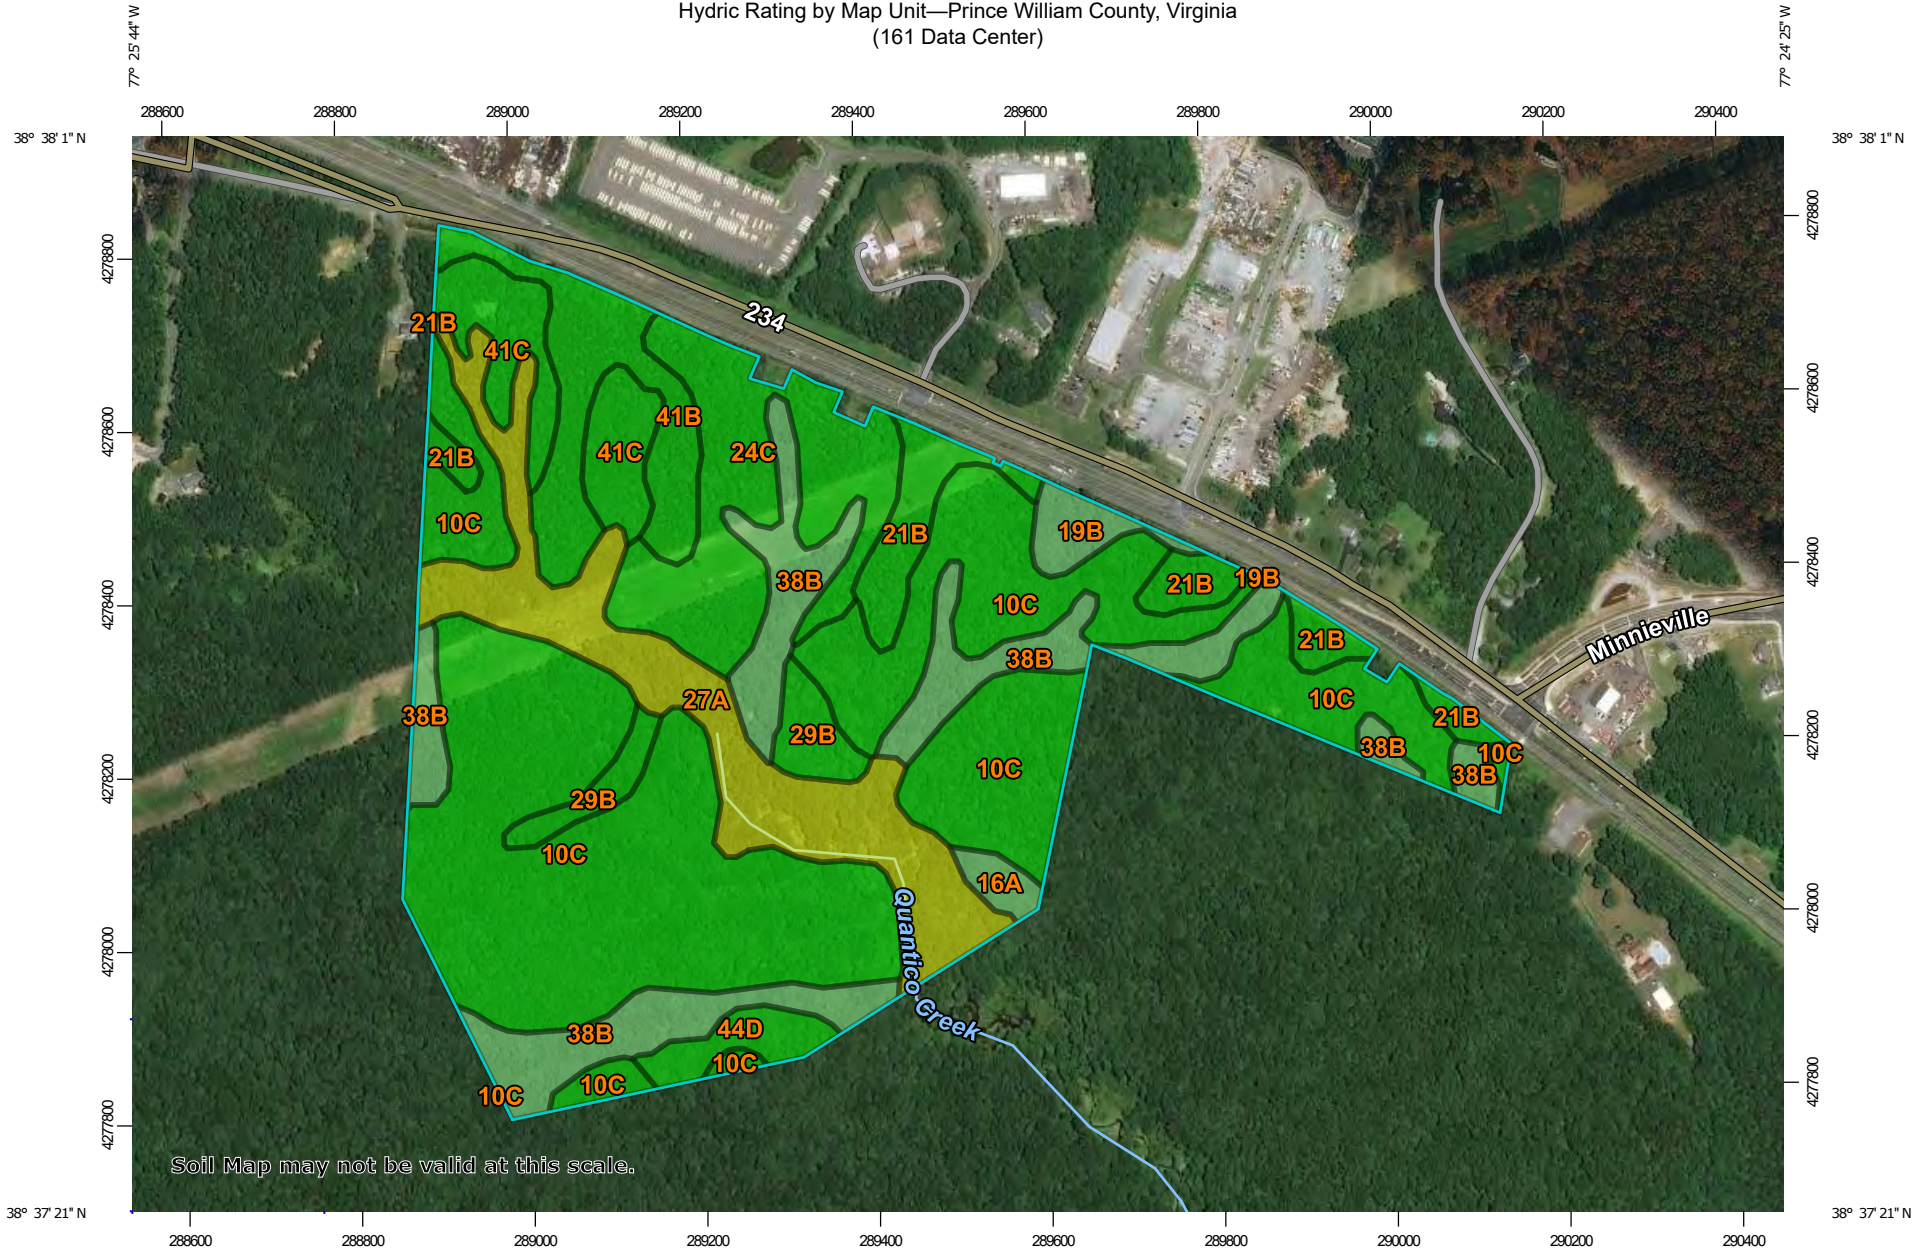
Hydric Rating by Map Unit—Prince William County, Virginia
(161 Data Center)

The soil survey indicates that the site is underlain primarily by Buckhall loam (10C), Delanco fine sandy loam (16A), Elioak loam (19B), Fairfax loam (21B), Glenelg-Buckhall (24C), Hatboro-Codorus (27A), Hoadly loam (29B), Meadowville loam (38B), Neabsco loam (41B, 41C) 0-7, 7-15 percent slopes, Occoquan sandy loam (44D). Delanco fine sandy loam (16A), Elioak loam (19B), Hatboro-Codorus (27A), and Meadowville loam (38B) are classified by the NRCS as hydric.

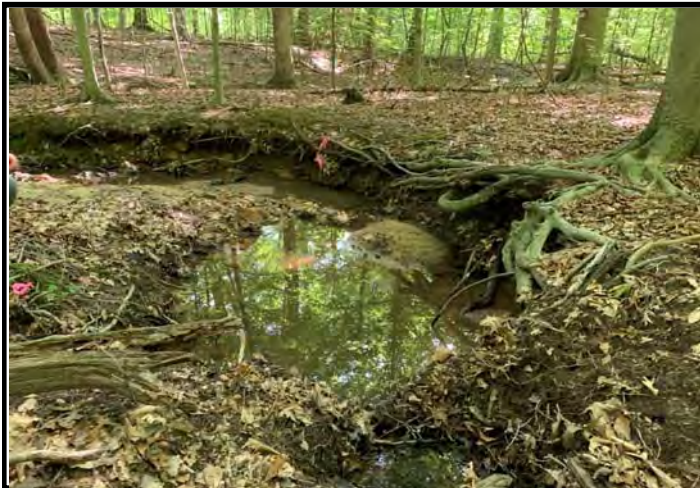
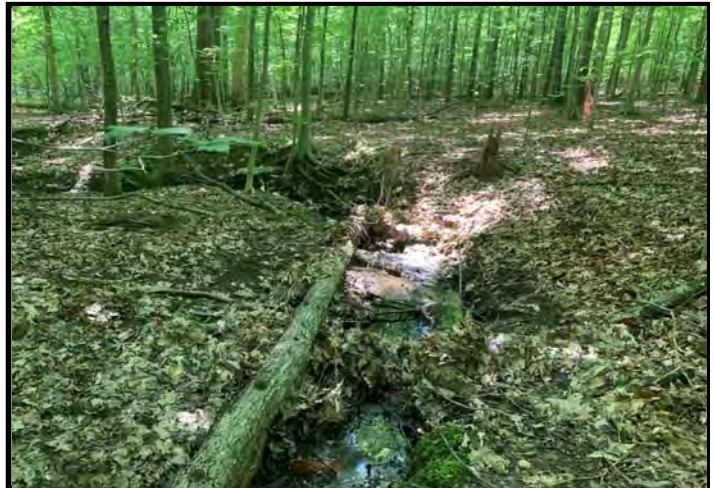
Approximate Reach Length: 1,782 **IS THIS REACH PERENNIAL?** Yes
 Average Channel Width: 6' Drainage area to the reach: 0.6 sq miles (384 acres)
 Average Channel Depth: 4"
 Average Water Depth: Riffles 1"
 Average Water Depth: Pools 7"
 Data Point Location: Flag G68

Upstream View of Channel

Downstream View of Channel

As detailed in the datasheet for the stream reach at PFD-1, this stream channel averages approximately six feet in width and drains southeast to Quantico Creek in the southern portion of the site. Flowing water was observed during the assessment. Drift lines, sedimentation, and leaf litter was also observed.

This second order stream exhibited a moderate continuous bed and bank, riffle-pool sequence, substrate sorting, sinuosity, and bankfull bench. Redoximorphic features were absent within the stream bank soils and the matrix contained a chroma of 2. Green algae and iron oxidizing bacteria was present. Many common benthic macroinvertebrates and amphibians, including crayfish, aquatic worms, beetles, snails, and tadpoles/toads, were observed throughout this portion of the reach.

Overall, the stream scored 29.5 on the Fairfax County Protocol and should be considered perennial.

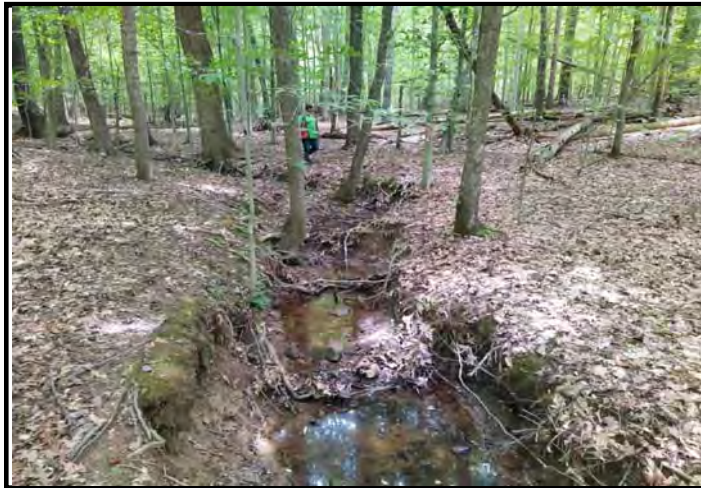
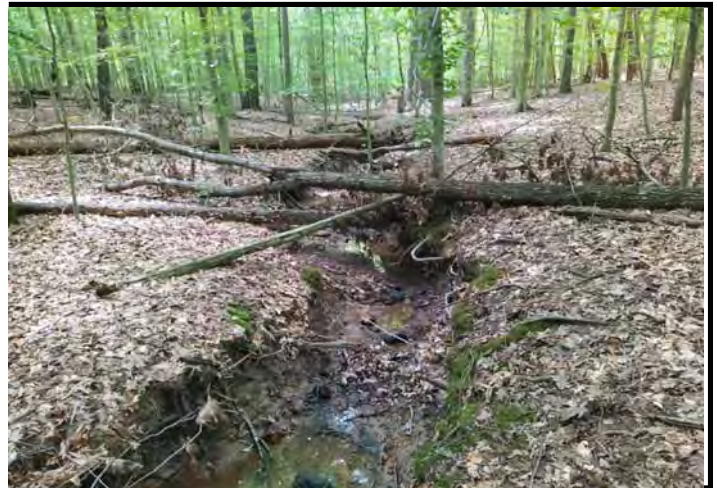
Approximate Reach Length:	<u>801</u>	IS THIS REACH PERENNIAL?	<input type="text" value="No"/>
Average Channel Width:	<u>3'</u>	Drainage area to the reach:	<u>0.07 sq miles (44.8 acres)</u>
Average Channel Depth:	<u>1"</u>		
Average Water Depth: Riffles:	<u>0.5</u>		
Average Water Depth: Pools:	<u>2"</u>		
Data Point Location:	<u>Flag O12</u>

Upstream View of Channel

Downstream View of Channel

As detailed in the datasheet for the stream reach at PFD-2, this stream channel averages approximately three feet in width and drains southwest to Quantico Creek. Flowing water was observed during the assessment. A high groundwater table, drift lines and leaf litter were also observed.

This first order stream exhibited a strong continuous bed and bank, with moderate riffle-pool sequence, substrate sorting, and sinuosity. Redoximorphic features were present within the stream bank soils and the matrix contained a chroma of 4. Green algae was observed, as were some common benthic macroinvertebrates and amphibians, including crayfish, aquatic worms, beetles, snails, and tadpoles/toads.

Overall, the stream scored 20 on the Fairfax County Protocol and should not be considered perennial.

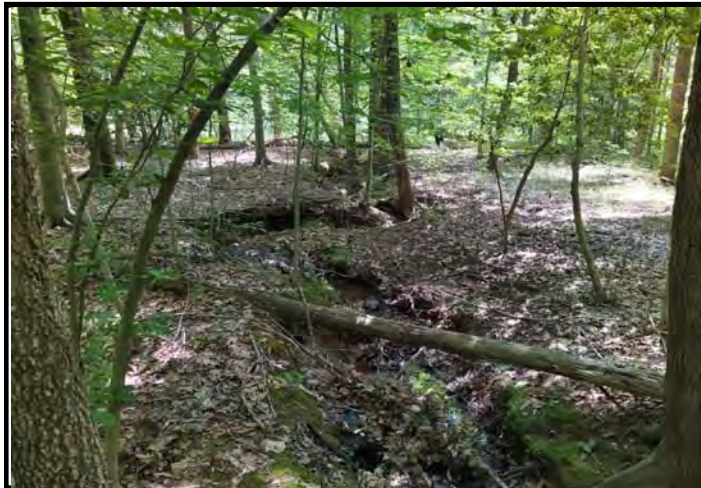
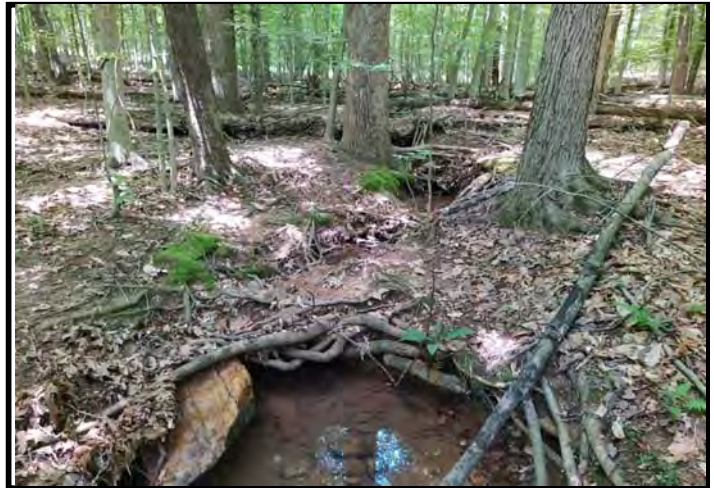
Approximate Reach Length: 581 **IS THIS REACH PERENNIAL?** No
 Average Channel Width: 4' Drainage area to the reach: 0.06 sq miles (38.4 acres)
 Average Channel Depth: 2"
 Average Water Depth: Riffles: 0.5"
 Average Water Depth: Pools: 3"
 Data Point Location: Flag VA9

Upstream View of Channel

Downstream View of Channel

Minor flow to the water, mainly standing pools.

As detailed in the datasheet for the stream reach at PFD-3, this stream channel averages approximately four feet in width and drains south to Quantico Creek. Some flowing water was observed during the assessment as was a high groundwater table, drift lines and leaf litter.

This first order stream exhibited a moderate continuous bed and bank, riffle-pool sequence, substrate sorting. Some sinuosity, bankfull bench and natural levees were also present. Redoximorphic features were absent within the stream bank soils and the matrix contained a chroma of 4. Green algae was observed, as were some common benthic macroinvertebrates and amphibians, including Water boatman, mosquito larvae, aquatic worms, snails, and tadpoles.

Overall, the stream scored 17.5 on the Fairfax County Protocol and should not be considered perennial.

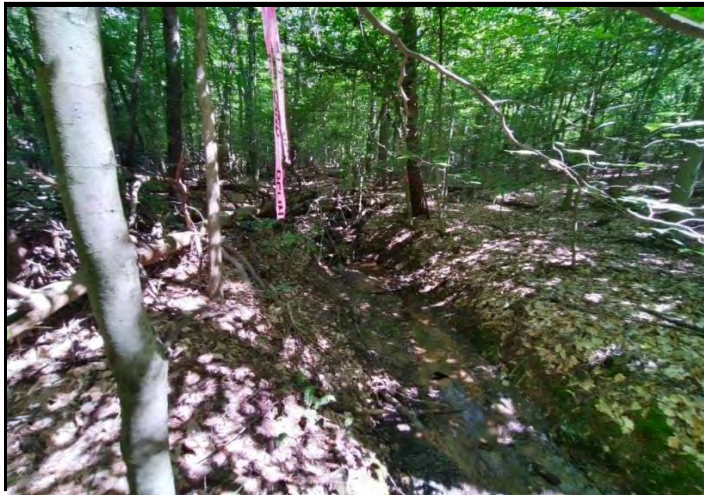
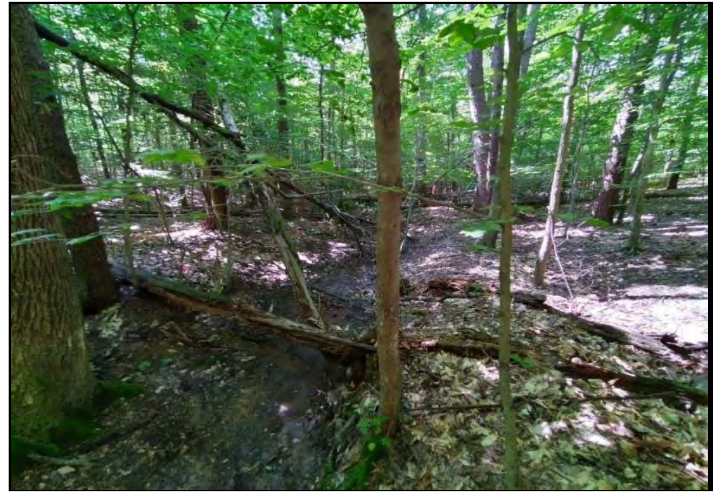
Upstream View of Channel

Downstream View of Channel

As detailed in the datasheet for the stream reach at PFD-4, this stream channel averages approximately four feet in width and drains south to Quantico Creek. Flowing water was absent during the assessment. Heavy leaf litter was present, with minimal drift lines and sediment deposits.

This first order stream exhibited a weak continuous bed and bank, riffle-pool sequence, and substrate sorting; however, all other geomorphological field indicators were absent. Redoximorphic features were absent within the stream bank soils and the matrix contained a chroma of 4. No benthic macroinvertebrates or amphibians were observed within the reach.

Overall, the stream scored 6.5 on the Fairfax County Protocol and should not be considered perennial.

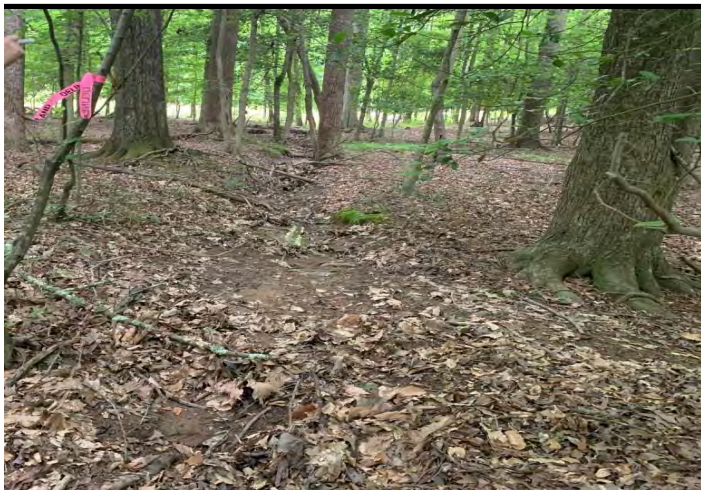
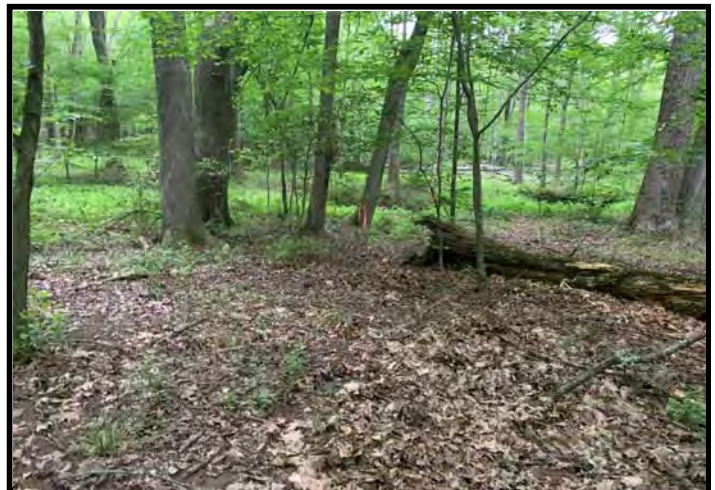
Upstream View of Channel

Downstream View of Channel

As detailed in the datasheet for the stream reach at PFD-4, this stream channel averages approximately one foot in width and drains north to Quantico Creek. Some ponded water was present during the assessment, but no apparent flow. Heavy leaf litter was present, with weak drift lines and sediment deposits.

This first order stream exhibited a weak continuous bed and bank, riffle-pool sequence, and sinuosity while all other geomorphological field indicators were absent. Redoximorphic features were absent within the stream bank soils and the matrix contained a chroma of 4. No benthic macroinvertebrates or amphibians were observed within the reach.

Overall, the stream scored 5 on the Fairfax County Protocol and should not be considered perennial.
